PURCHASE ORDER

PO No. : 4021012182
PO Date : 19.04.2022
PO Currency : IDR

VALVE INCOMING INSPECTION

{ BLOWDOWN VALVE }

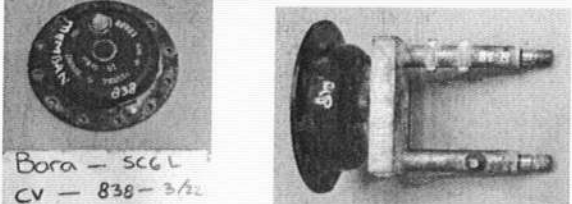
<p style="text-align: center;">Diaphragm Housing + Yoke</p> <div style="border: 1px solid black; padding: 5px; width: fit-content;"> <p>Bora - SCGL CV - 838 - 3/22 Blowdown DN25 PN40 Inspection Before Repair</p> </div>

<p style="text-align: center;">Diaphragm housing + yoke was found corroded dirty need to cleaned up and painting</p>	<p style="text-align: center;">Diaphragm Housing + Yoke</p>
