Item [10] Supplies for Repair Blowdown Valve DN40

VALVE INCOMING INSPECTION

(CONTROL VALVE)

Manufacturer	: ARI ARMATUREN
Type/ Model	: BLOW DOWN
Figure No.	: 415
Serial No.	: N/A
Size - Class	: DN 40 PN 40

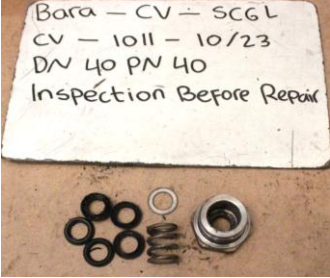
<p>Packing set was found damage need to replaced</p>	
Bolt & Nut	Bolt & Nut

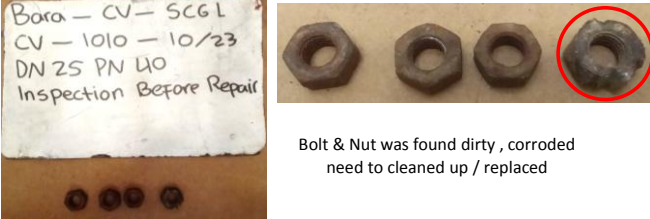
1. 2 & 4 Bolt & Nut was found damage, it's should be replaced.

<p>Bolt & Nut was found dirty , corroded need to cleaned up / replaced</p>	
Spring	Spring
