VALVE INCOMING INSPECTION

(CONTROL VALVE)

BARA Code No.	: BARA-CV-SCGL	Job Given By	: Mrs. Ane
PO BARA No.	: 1011	Date Received	: 17-10-23
Cust PO / WO No	: 4021014138	Date Inspection	: 19-10-23
Customer Name	: PT. SCG LIGHTWEIGHT	Receive Condition	: Failed

Manufacturer	: ARI ARMATUREN
Type/ Model	: BLOW DOWN
Figure No.	: 415
Serial No.	: N/A
Size - Class	: DN 25 PN 40

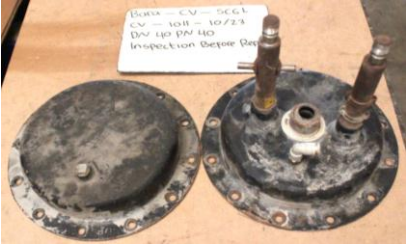
<p>Bara - CV - SCGL CV - 1011 - 10/23 DN 40 PN 40 Inspection Before Repair</p> <p>Diaphragm Housing was found dirty need to cleaned up</p>

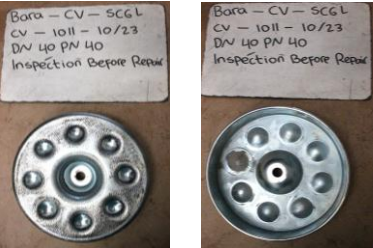
<p data-bbox="634 779 846 821">Spring plate was found dirty need to cleaned up</p>	
Diaphragm / Membran	Diaphragm / Membran

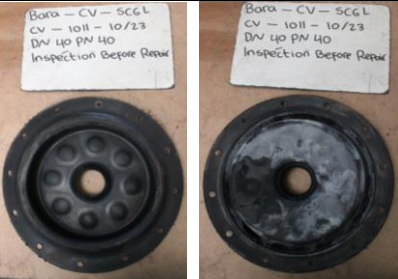
<p data-bbox="638 1077 846 1140">Diaphragm / Membran was found damage need to replaced</p>	
Coupling	Coupling
