VALVE INCOMING INSPECTION

(CONTROL VALVE)

BARA Code No.	: BARA-CV-SCGL	Job Given By	: Mrs. Ane
PO BARA No.	: 1010	Date Received	: 17-10-23
Cust PO / WO No	: 4021014138	Date Inspection	: 19-10-23
Customer Name	: PT. SCG LIGHTWEIGHT	Receive Condition	: Failed

Manufacturer	: ARI ARMATUREN
Type/ Model	: BLOW DOWN
Figure No.	: 415
Serial No.	: N/A
Size - Class	: DN 40 PN 40

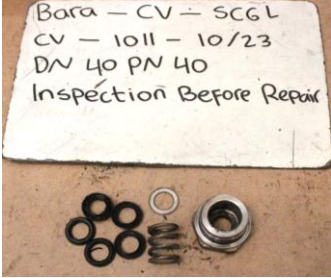
<p>Packing set was found damage need to replaced</p>	
Bolt & Nut	Bolt & Nut

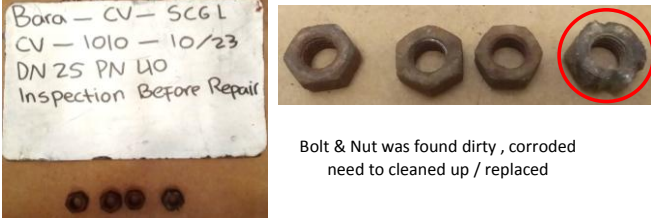
<p>Bolt & Nut was found dirty , corroded need to cleaned up / replaced</p>	
Spring	Spring

1. 2 & 4 Bolt & Nut was found damage, it's should be replaced.
