Item [10] Add. Job Repair Blowdown Valve DN25

VALVE INCOMING INSPECTION

(CONTROL VALVE)

Manufacturer	: ARI ARMATUREN
Type/ Model	: BLOW DOWN
Figure No.	: 415
Serial No.	: N/A
Size - Class	: DN 25 PN 40

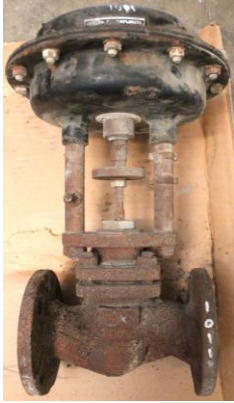
<p align="center">Body</p>	<p align="center">Body</p>

<p data-bbox="483 730 776 779">Body was found dirty,corroded need to cleaned up</p>	
<p align="center">Bonnet</p>	<p align="center">Bonnet</p>

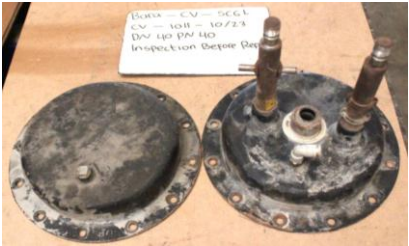
<p data-bbox="630 1707 776 1770">Diaphragm Housing was found dirty need to cleaned up</p>
